**DEPARTMENT OF TRANSPORTATION**

Contract #: 04-0120F4Cty: SF/ALA Rte: 80 PM: 13.2/13.9File #: 69.28**WELDING INSPECTION REPORT****Resident Engineer:**Siegenthaler, Peter**Address:** 333 Burma Road**City:** Oakland, CA 94607**Report No:** WIR-019380**Date Inspected:** 17-Jan-2011**Project Name:** SAS Superstructure**OSM Arrival Time:** 700**Prime Contractor:** American Bridge/Fluor Enterprises, a JV**OSM Departure Time:** 1900**Contractor:** Zhenhua Port Machinery Company, Ltd (ZPMC), Changxing Island **Location:** Shanghai, China**CWI Name:** An Qing Xiang, Qiu Wen**CWI Present:** Yes No**Inspected CWI report:** Yes No N/A**Rod Oven in Use:** Yes No N/A**Electrode to specification:** Yes No N/A**Weld Procedures Followed:** Yes No N/A**Qualified Welders:** Yes No N/A**Verified Joint Fit-up:** Yes No N/A**Approved Drawings:** Yes No N/A**Approved WPS:** Yes No N/A**Delayed / Cancelled:** Yes No N/A**Bridge No:** 34-0006**Component:** OBG**Summary of Items Observed:**

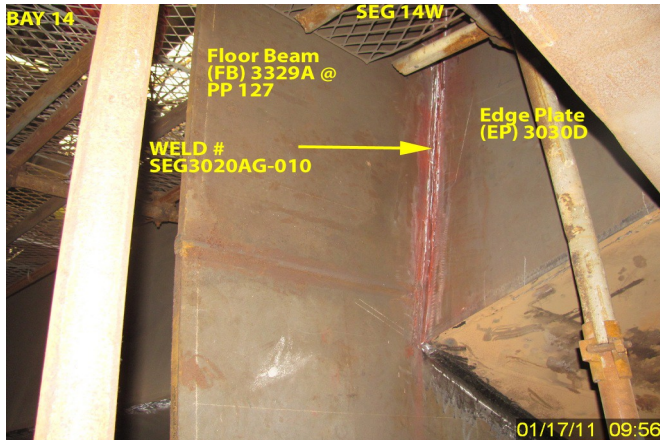
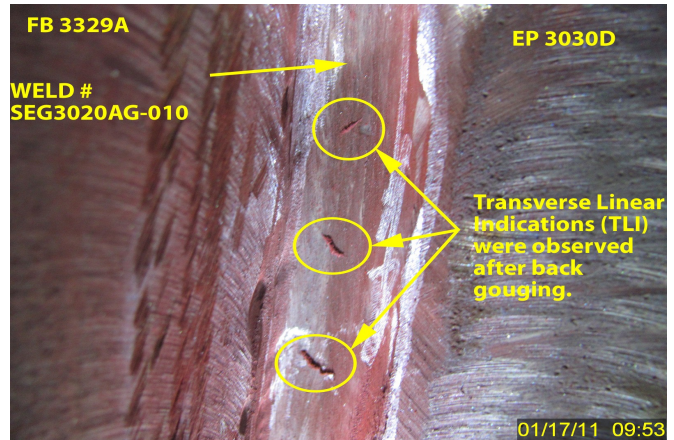
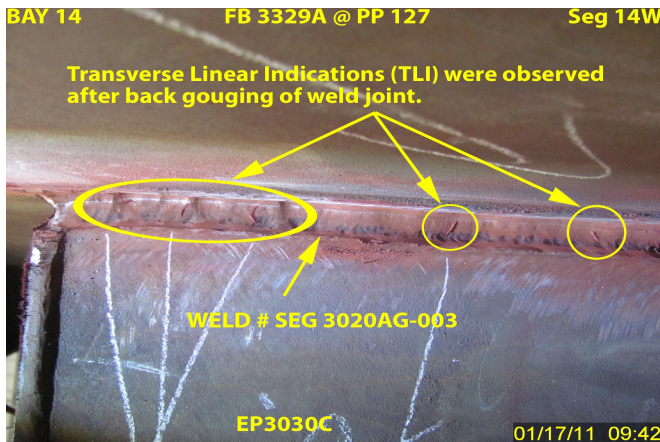
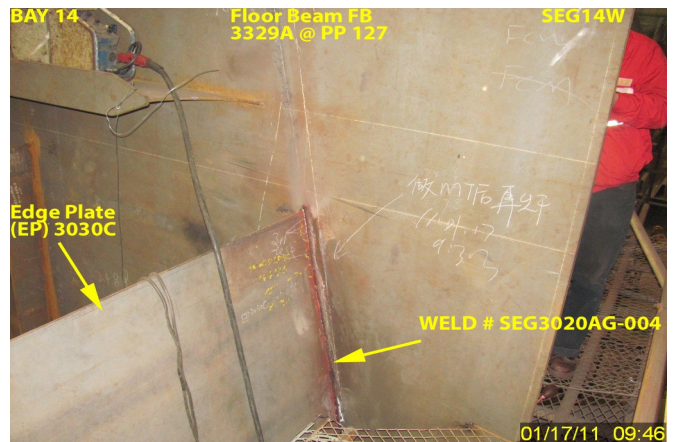
During random in process inspection this QA Inspector observed that the back gouging is done for Edge Plate (EP) 3030C/3030D to Floor Beam (FB) 3329A, complete joint penetration (CJP) welds (at PP 127). However, for weld no: SEG3020AG-003, 010 transverse cracks were observed after back gouging. This QA Inspector informed about this to ZPMC CWI Mr. An Qing Xiang and CT lead QA. ZPMC will be submitting CWR, before proceeding welding of this joint. Attached photographs provide additional details.
